## ***The Pros and Cons of Stainless Steel Use in Natatoriums***

**BY CATHERINE HOUSKA, CSI AND JAMES FRITZ, PH.D**

(Extracted from Construction Specifier Magazine, December 2005)

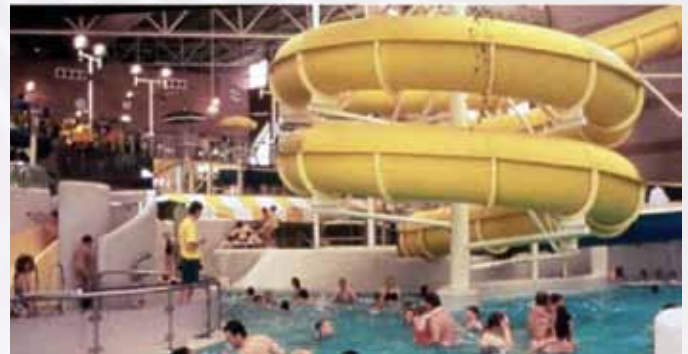
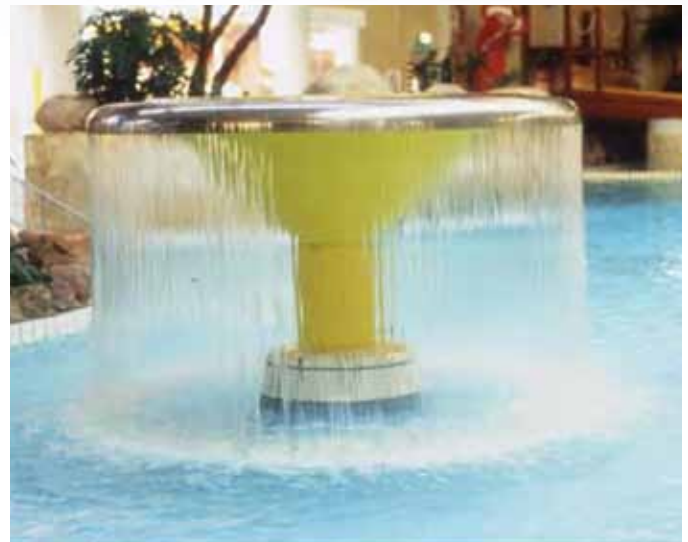
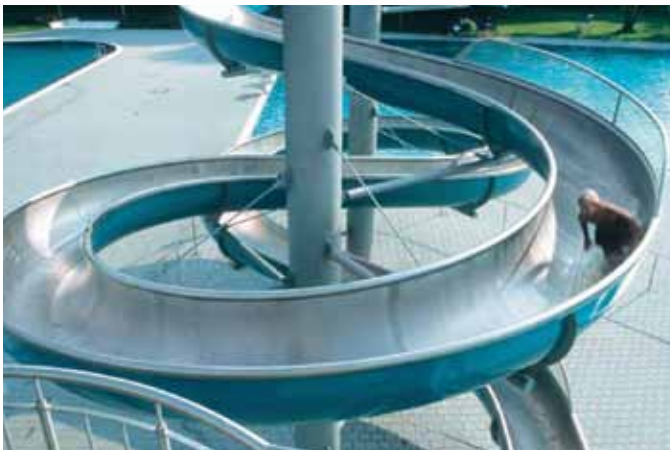
Figure 1 (Photo Courtesy of Nickel Institute)

*Figures 1, 2 and 3: Stainless steel swimming pool slide and water feature.*

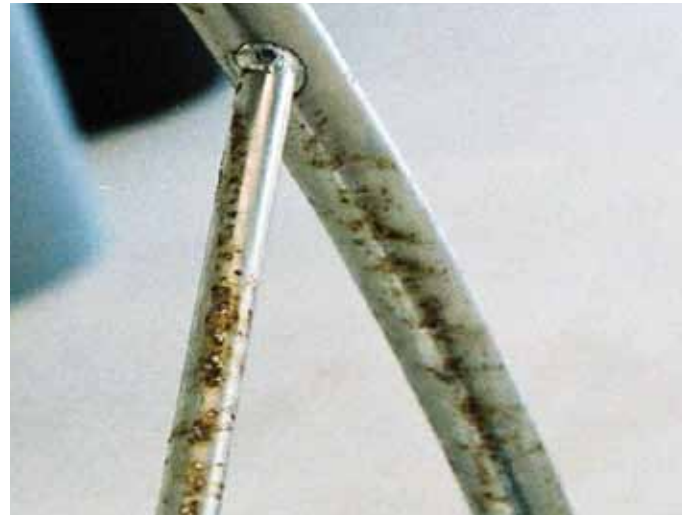
*Figure 4: This chrome plated carbon steel reel for holding lane markers has only been in use for a few years but there has already been substantial corrosion under the plating. Photo Courtesy of TMR Consulting.*

Other less corrosion resistant metals are sometimes used in swimming pool applications. The relative installed cost of aluminum is lower and the corrosion of aluminum components is often overlooked because its corrosion product is white to whitish gray in appearance. The significantly higher corrosion rate of aluminum in chloride-containing environments makes inspection important so that metal corrosion loss and structural integrity can be determined. Relatively low cost painted and plated carbon steel are sometimes used for pool applications, but their performance is dependent on coating quality and maintenance. Once the protective coating or plating starts to fail, there can be rapid corrosion and structural deterioration of the carbon steel making careful regular inspection and recoating necessary.

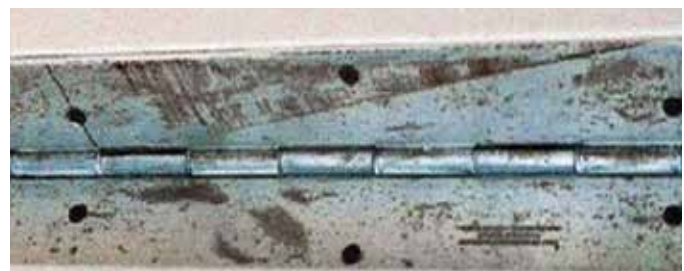
*Figure 5: Carbon steel brushes were used by a cleaning contractor on this stainless steel door hinge that was installed beside an indoor swimming pool. The areas with carbon steel contamination are rusting. Photo courtesy of TMR Consulting*

Poor maintenance and the use of inappropriate cleaning compounds can be another factor in corrosion performance. Carbon steel wool and wire brushes should never be used for cleaning or 'refinishing' stainless steel since particles can become embedded in the surface. These carbon steel particles corrode at the same rate as unprotected carbon steel and cause unsightly surface damage.

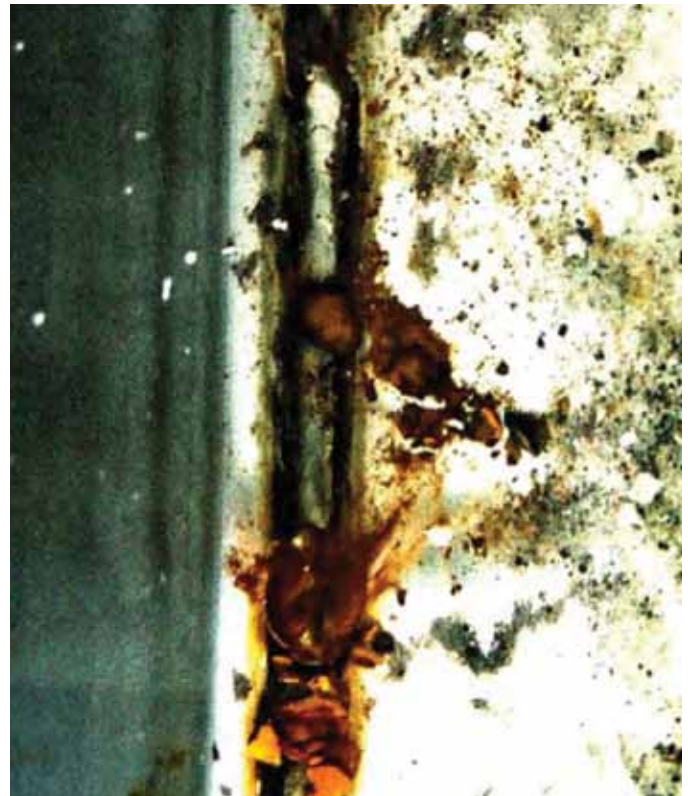
*Figure 6: This weld within a swimming pool gutter was not cleaned properly and pitting corrosion is occurring along the weld seam. Photo courtesy of TMR Consulting*

In cases where stainless steel components have welded joints, the welds should provide the same level of corrosion performance as the surrounding metal. Therefore, corrosion on and around welded stainless steel joints is unacceptable. Grinding and pickling joints is the best means of restoring a weld's corrosion resistance.

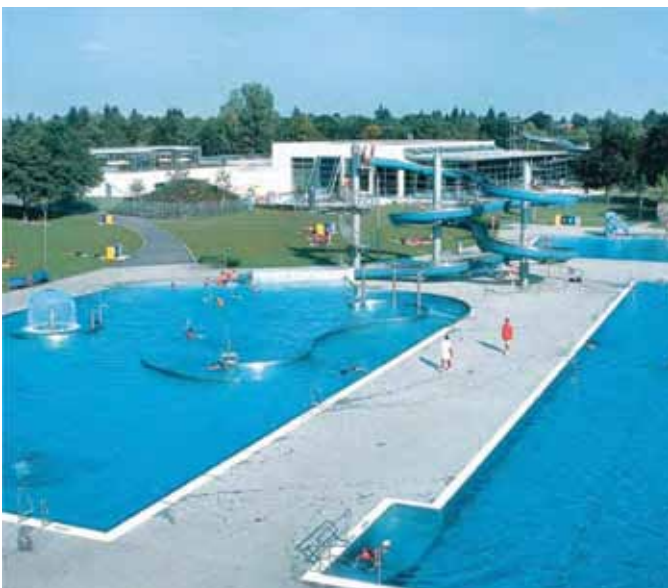
Figure 8: This swimming pool in Munich, Germany was relined with Type 316 stainless steel panels that were welded together. Photo courtesy of Martina Helzel

Bare Type 316 stainless steel has been used for pool linings, particularly in Europe.<sup>8</sup> In relining applications, stainless steel has replaced plastic and ceramic tiles, while in new pools, self-supporting structures composed of stainless steel sheet and structural framing are typically used for water depths up to about 2 m (6.5 ft). Deeper pools typically require a secondary support structure or heavier wall panels due to water pressure loads. The stainless steel panels are welded together, producing a watertight structure, and the seams are pickled to restore corrosion resistance. Pool lane markings can be applied in advance using electrochemical coloring, which eliminates maintenance painting.

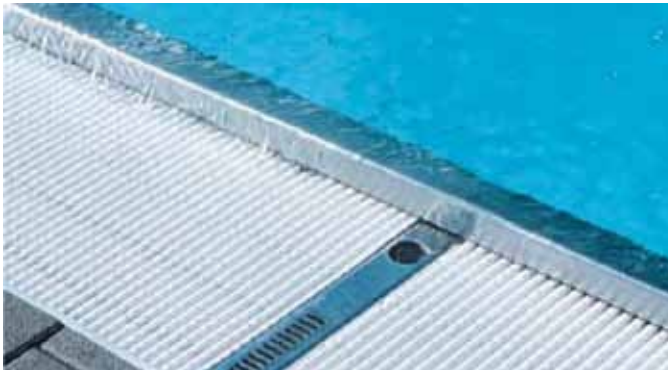
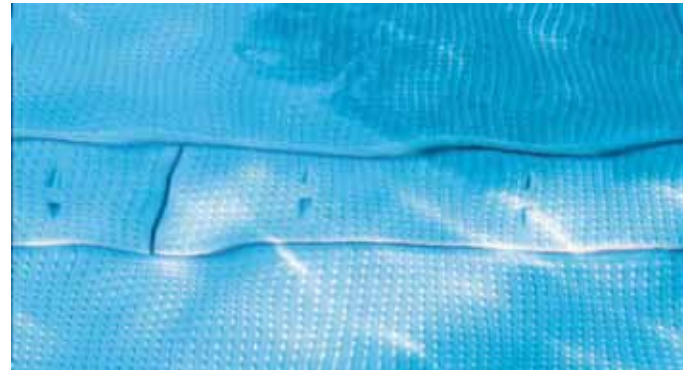
Figure 10 and 11: Type 316 pool gutters and water jet openings in the floor plates. Photos courtesy of Martina Helzel

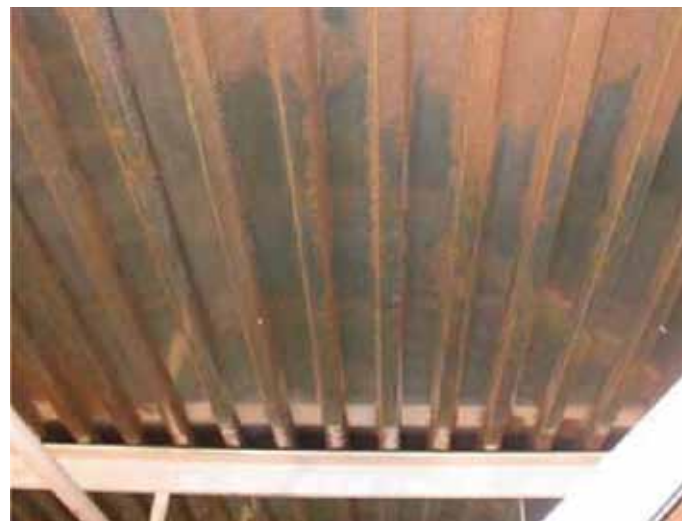
Figure 12: Corrosion of a Type 304 stainless steel roof deck above an indoor swimming pool. Photo courtesy TMR Consulting

SCC is a concern in load-bearing applications that are not splashed with pool water or cleaned, such as ceiling hangers, fasteners, brackets, supports, bolts, wires, cables, and hooks. Figures 12 and 13 depict an example of SCC attack. This North American Type 304 stainless steel natatorium roof deck was never inspected or cleaned. After a decade of exposure, there was significant brown staining on the roof panels above the diving platforms. Samples were removed from the roof deck and close examination revealed shallow pitting and extensive cracking with some fissures penetrating 80 percent of the cross-section. This cracking resulted because of the following factors:

- The stainless steel was susceptible to SCC.
- There were relatively high residual stresses from the cold working the roof panels and high roof service stress loads, particularly with winter snow loads.
- There was no cleaning to remove the accumulation of aggressive chloride compounds.
- It was a poorly controlled pool environment.
